M Brady Inspections LLC

1234 Any St.
Orinda, California
February 00, 2011 - 2:00 p.m.
Report Number 11000

This Report Prepared for
Sample report

Inspected by Michael Brady
Member: American Society of Home Inspectors (ASHI)
Member: International Code Council (ICC)

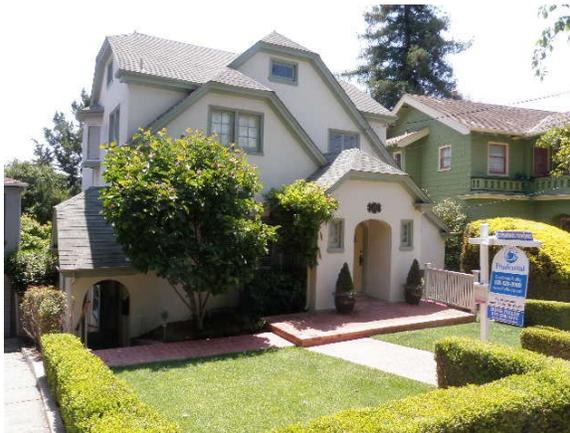
Front view.

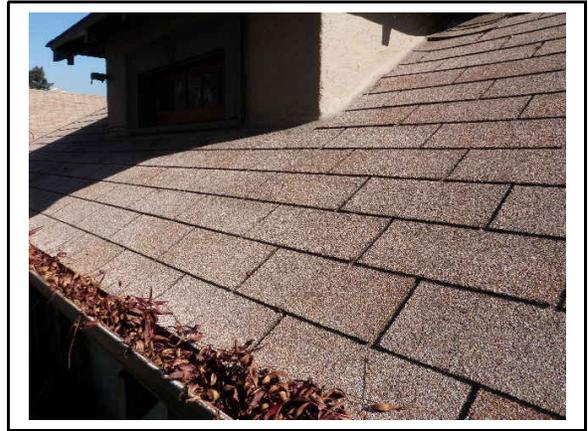
The building has a composition shingle roof, which is in moderately to generally worn condition.

Roof in moderately to generally worn condition.

We recommend the need for roof surface replacement within the next few years be anticipated.

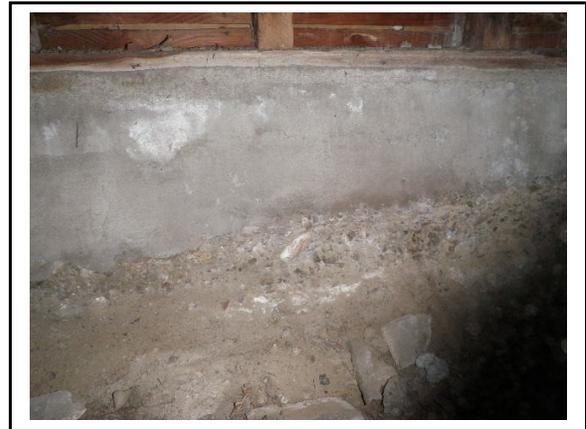
Concrete caps have been installed at the tops of all of the foundation walls. The newer concrete forms a cap over the original, old concrete.

New caps on old concrete foundation.

The older portions of the foundation show substantial concrete deterioration. Portions or all of the foundation may soon need replacement. We recommend a qualified engineer be consulted to determine the extent of concrete deterioration and which portions of the foundation will need replacement in the reasonably foreseeable future.
